Report on the Breaking of a Girth-Hitched Sling, prepared by Mammut Sports Group.  
1/10/2007

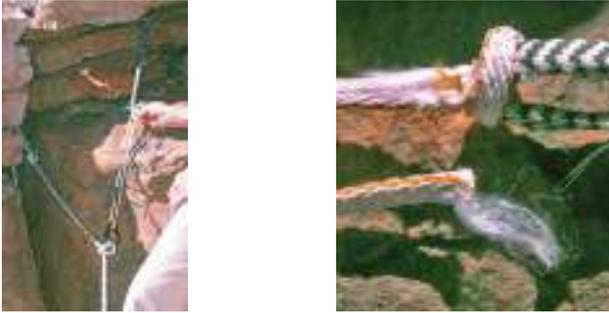
Above: The anchor and the broken sling in question.

However, based on the fact that a UIAA certified sling holds at least 22kn (roughly 5000lbs), when girth hitched 880DaN or 2000lbs strength should remain in the worst case. With normal human weight and under the described circumstances of the accident, this force could only have been reached with a multi-meter drop. Because of the lack of melting and the lack of similarity to any of the tested breaks, we do not believe the sling broke due to any force applied to it, even taking into consideration the weakening effect of the girth-hitch. The most plausible scenario, borne out by the linear characteristics of the break and location of the break outside the knot, is that the sling was cut with a very sharp object. The only difference is the pulled thread—it seems plausible that this thread could have been the only one not cut through and therefore it held the anchor in place so it appeared to be intact, and finally it broke under a relatively low load.

Climbers should be aware that all slings, whether skinny or fat, Dyneema/Spectra or Nylon, are susceptible to significant strength loss due to a girth hitch, and should use any connecting knots with extreme caution. The safest way to obtain a longer sling is to carry and use a longer sling in the first place, rather than connecting them at all. If two slings must be joined, the strongest way to do so is with a carabiner.

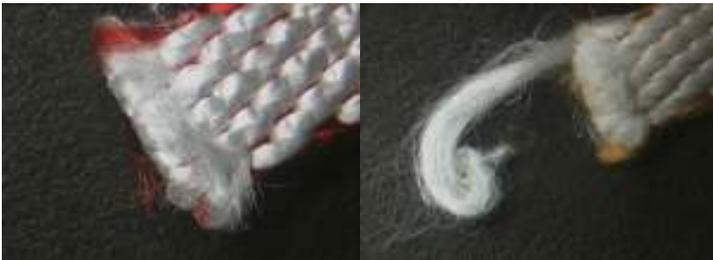
After conducting a series of tests using static, dynamic and cyclic load testing to attempt to reproduce the conditions of the accident the broken sling was compared to the broken test samples using a microscope to examine the break characteristics, which are indicative of the mechanism of breakage. The broken sling did not exhibit any sign of chemical contamination, there was no melting of the fiber ends as is always the case in slings broken under load, the break was located outside the girth hitch rather than inside as would be expected if the knot were the source of the weakness, and the linear break very closely matched those achieved by cutting in the test samples.

Above: A sling that was cut with a knife on the left, next to the broken sling.

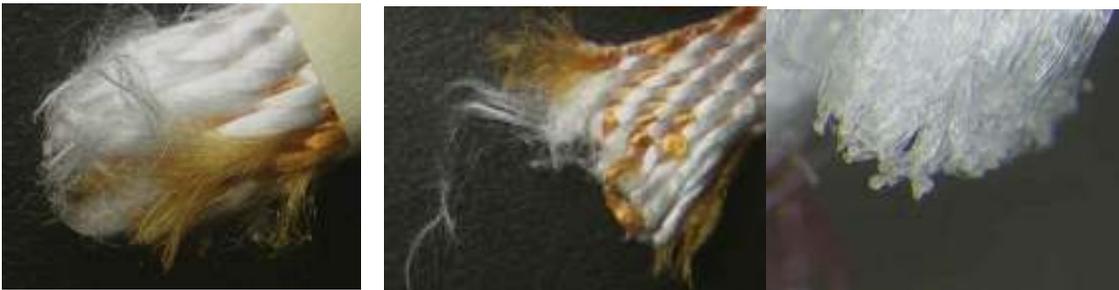
Above: Typical examples of breaks caused by a dynamic load (left), being cut over a sharp edge during an impact (middle), and the melting of the fibers that occurs when broken under load.
